**Flood Control Project Maintenance  
Levee Inspections**

**Fall 2018 Levee Maintenance Deficiency Summary Report**

**LMA District Cover Sheet**  
**Fall 2018 Levee Inspection Results**

**Sutter Maintenance Yard Maintenance Area 0005**

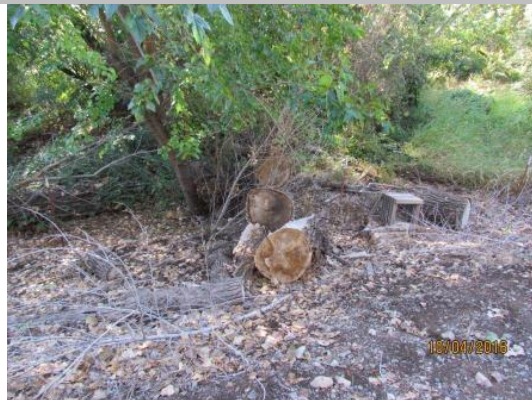
Photo 1 of 1 : FA\_2018\_MA0005\_196\_45\_20180905\_00022.jpg

LM Start	0.05	Rating **	M	Issue No.	45
LM End	0.05	Issue Type +	Ma	Location *	LS
Category	Earthen Levee			GPS Latitude/Longitude	
				Start	End
Item	Trim / Thin Trees			39.696790 °	39.696790 °
				-121.774154 °	-121.774154 °
DWR ID	DWR_MA0005_01_f_2016_45				
Comment Code					
T1 : Trim trees to at least five feet above ground level.					
Inspector Comment					
Remove wood logs from the waterside slope and trim trees to at least five feet above the levee slope.

View of the wood logs on the landside slope.

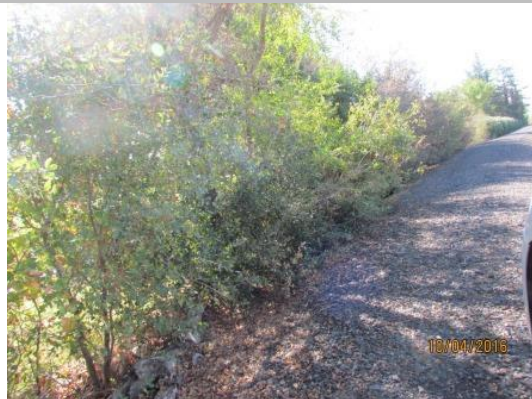
Photo 1 of 1 : FA\_2018\_MA0005\_196\_32\_20180905\_00012.jpg

LM Start	0.58	Rating **	M	Issue No.	32
LM End	0.68	Issue Type +	Ma	Location *	LS
Category	Earthen Levee			GPS Latitude/Longitude	
				Start	End
Item	Trim / Thin Trees			39.690496°	39.689137°
				-121.777109°	-121.776938°
DWR ID	DWR_MA0005_01_s_2014_32				
Comment Code					
T2 : Thin trees to allow visibility of the ground and room to flood fight.					
Inspector Comment

View of the trees along the landside toe blocking visibility.

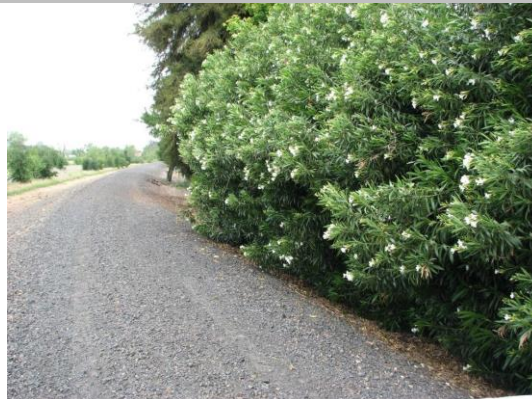
Photo 1 of 1 : FA\_2018\_MA0005\_196\_44\_20180905\_00021.jpg

LM Start	0.68	Rating **	U	Issue No.	44
LM End	0.77	Issue Type +	En	Location *	LS
Category	Earthen Levee			GPS Latitude/Longitude	
				Start	End
Item	Vegetation			39.689135 °	39.687968 °
				-121.776929 °	-121.777387 °
DWR ID	DWR_MA0005_01_s_2016_44				
Comment Code					
V6 : Landscaping					
Inspector Comment

View of oleanders along the landside toe.

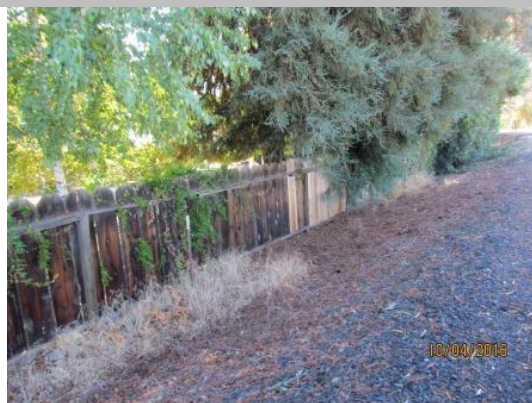
Photo 1 of 1 : FA\_2018\_MA0005\_196\_49\_20180905\_00024.jpg

LM Start	0.90	Rating **	U	Issue No.	49
LM End	0.92	Issue Type +	En	Location *	LS
Category	Earthen Levee			GPS Latitude/Longitude	
				Start	End
Item	Encroachments			39.686087 °	39.685756 °
				-121.777555 °	-121.777540 °
DWR ID	DWR_MA0005_01_f_2016_49				
Comment Code					
FE : Fence					
Inspector Comment

View of the wood plank fence at the landside toe.

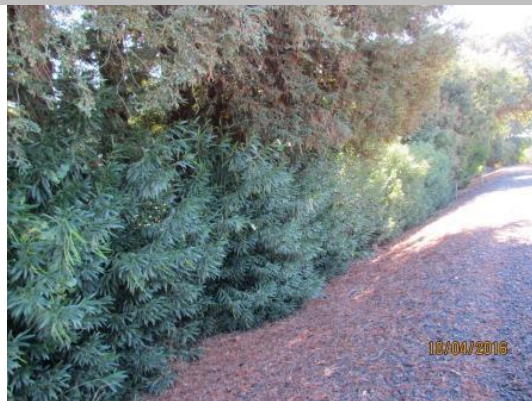
Photo 1 of 1 : FA\_2018\_MA0005\_196\_50\_20180905\_00025.jpg

LM Start	0.98	Rating **	U	Issue No.	50
LM End	1.00	Issue Type +	En	Location *	LS
Category	Earthen Levee			GPS Latitude/Longitude	
				Start	End
Item	Vegetation			39.684843 °	39.684606 °
				-121.777132 °	-121.776975 °
DWR ID	DWR_MA0005_01_f_2016_50				
Comment Code					
V6 : Landscaping					
Inspector Comment					
Oleanders blocking visibility.

View of the oleanders along the landside toe.

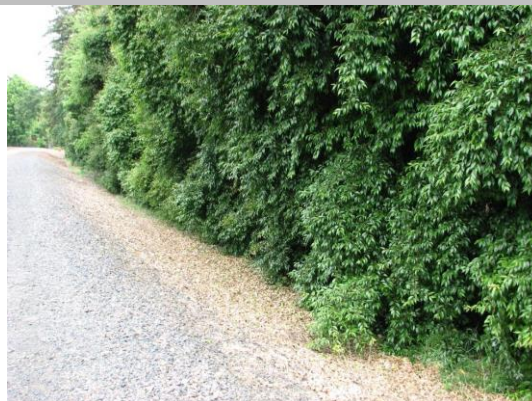
Photo 1 of 1 : FA\_2018\_MA0005\_196\_43\_20180905\_00020.jpg

LM Start	1.16	Rating **	M	Issue No.	43
LM End	1.24	Issue Type +	En	Location *	LS
Category	Earthen Levee			GPS Latitude/Longitude	
				Start	End
Item	Vegetation			39.682402 °	39.681322 °
				-121.776405 °	-121.776506 °
DWR ID	DWR_MA0005_01_s_2016_43				
Comment Code					
V6 : Landscaping					
Inspector Comment

View of the overgrown vegetation at the landside toe.

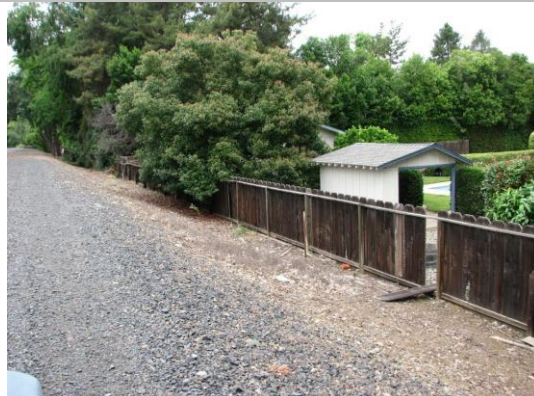
Photo 1 of 1 : FA\_2018\_MA0005\_196\_42\_20180905\_00019.jpg

LM Start	1.24	Rating **	U	Issue No.	42
LM End	1.26	Issue Type +	En	Location *	LS
Category	Earthen Levee			GPS Latitude/Longitude	
				Start	End
Item	Encroachments			39.681305 °	39.681044 °
				-121.776533 °	-121.776547 °
DWR ID	DWR_MA0005_01_s_2016_42				
Comment Code					
FE : Fence					
Inspector Comment

View of the wood plank fence at the landside toe.

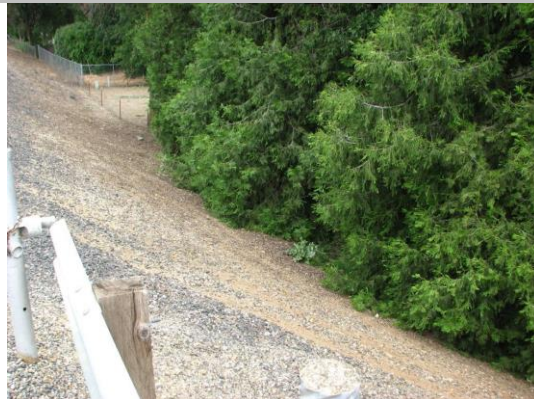
Photo 1 of 1 : FA\_2018\_MA0005\_196\_40\_20180905\_00018.jpg

LM Start	1.45	Rating **	M	Issue No.	40
LM End	1.45	Issue Type +	En	Location *	LS
Category	Earthen Levee			GPS Latitude/Longitude	
				Start	End
Item	Vegetation			39.678318 °	39.678318 °
				-121.777231 °	-121.777231 °
DWR ID	DWR_MA0005_01_s_2016_40				
Comment Code					
V6 : Landscaping					
Inspector Comment					
Cedar trees need to be trimmed up.

View of the overgrown cedar trees on the landside toe.

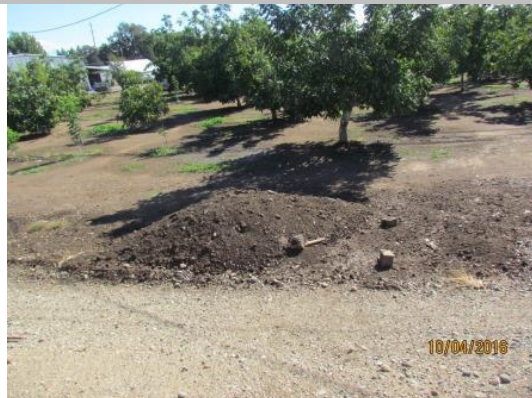
Photo 1 of 1 : FA\_2018\_MA0005\_196\_53\_20180905\_00026.jpg

LM Start	1.52	Rating **	M	Issue No.	53
LM End	1.52	Issue Type +	En	Location *	LS
Category	Earthen Levee			GPS Latitude/Longitude	
				Start	End
Item	Encroachments			39.677240 °	39.677240 °
				-121.777521 °	-121.777521 °
DWR ID	DWR_MA0005_01_f_2016_53				
Comment Code					
DE : Debris					
Inspector Comment					
Remove the pile of soil and rocks on the landside toe.

View of the soil and rock pile on the landside toe.

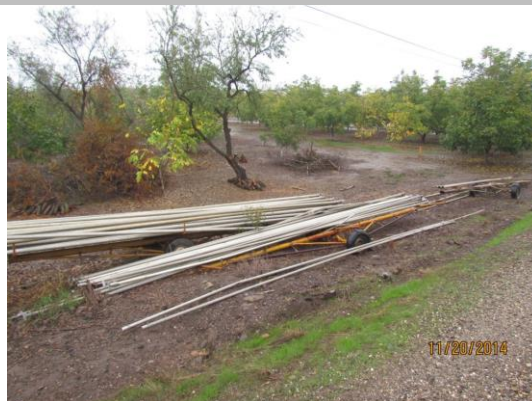
Photo 1 of 1 : FA\_2018\_MA0005\_196\_30\_20180905\_00010.jpg

LM Start	1.53	Rating **	M	Issue No.	30
LM End	1.53	Issue Type +	En	Location *	LS
Category	Earthen Levee			GPS Latitude/Longitude	
				Start	End
Item	Encroachments			39.677130 °	39.677130 °
				-121.777583 °	-121.777583 °
DWR ID	DWR_MA0005_01_f _ 2014_30				
Comment Code					
EQ : Equipment					
Inspector Comment

View of the sprinkler pipe and equipment along the landside toe.

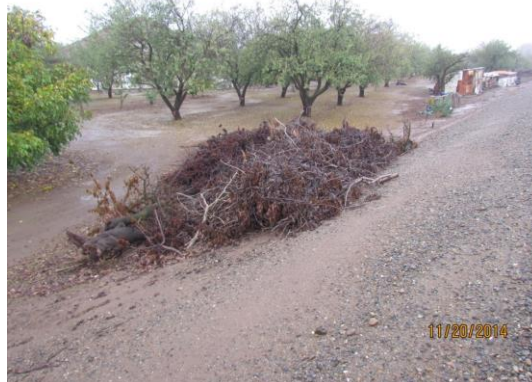
Photo 1 of 1 : FA\_2018\_MA0005\_196\_34\_20180905\_00013.jpg

LM Start	1.64	Rating **	U	Issue No.	34
LM End	1.64	Issue Type +	En	Location *	LS
Category	Earthen Levee			GPS Latitude/Longitude	
				Start	End
Item	Encroachments			39.675763 °	39.675763 °
				-121.778485 °	-121.778485 °
DWR ID	DWR_MA0005_01_f_2014_34				
Comment Code					
PR : Prunings					
Inspector Comment

View of the prunings along the landside toe.

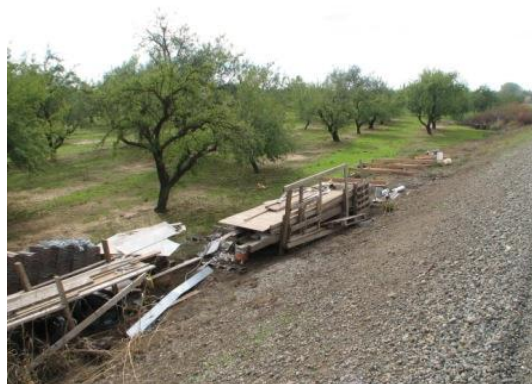
Photo 1 of 1 : FA\_2018\_MA0005\_196\_1\_20180905\_00001.jpg

LM Start	1.66	Rating **	M	Issue No.	1
LM End	1.66	Issue Type +	En	Location *	LS
Category	Earthen Levee			GPS Latitude/Longitude	
				Start	End
Item	Encroachments			39.675528 °	39.675528 °
				-121.778642 °	-121.778642 °
DWR ID	DWR_MA0005_01_s_2012_1				
Comment Code					
DE : Debris					
Inspector Comment

View of the construction supply on pallets.

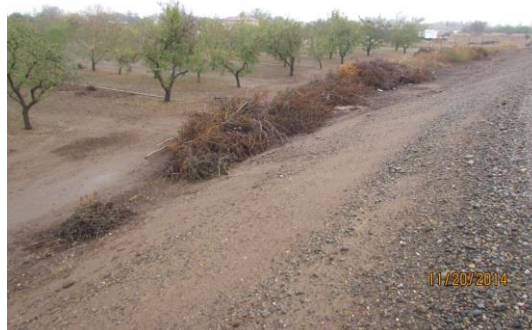
Photo 1 of 1 : FA\_2018\_MA0005\_196\_35\_20180905\_00014.jpg

LM Start	1.88	Rating **	M	Issue No.	35
LM End	1.88	Issue Type +	En	Location *	LS
Category	Earthen Levee			GPS Latitude/Longitude	
				Start	End
Item	Encroachments			39.672627 °	39.672627 °
				-121.779778 °	-121.779778 °
DWR ID	DWR_MA0005_01_f_2014_35				
Comment Code					
PR : Prunings					
Inspector Comment					
Remove the prunings from the landside toe.

View of the prunings along the landside toe.

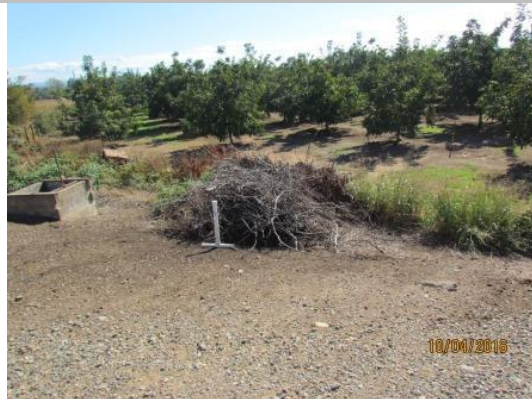
Photo 1 of 1 : FA\_2018\_MA0005\_196\_54\_20180905\_00027.jpg

LM Start	2.10	Rating **	M	Issue No.	54
LM End	2.10	Issue Type +	En	Location *	LS
Category	Earthen Levee			GPS Latitude/Longitude	
				Start	End
Item	Encroachments			39.670018 °	39.670018 °
				-121.781997 °	-121.781997 °
DWR ID	DWR_MA0005_01_f_2016_54				
Comment Code					
PR : Prunings					
Inspector Comment					
Remove the prunings from the landside toe.

View of the prunings along the landside toe.

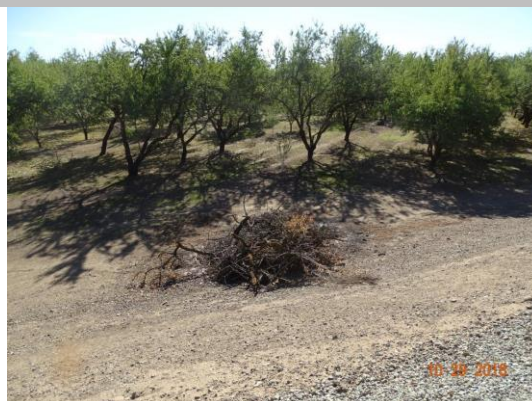
Photo 1 of 1 : FA\_2018\_MA0005\_196\_65\_20181106\_00088.jpg

LM Start	2.82	Rating **	M	Issue No.	65
LM End	2.82	Issue Type +	En	Location *	LS
Category	Earthen Levee			GPS Latitude/Longitude	
				Start	End
Item	Encroachments			39.660153 °	39.660153 °
				-121.785137 °	-121.785137 °
DWR ID	DWR_MA0005_01_f _ 2018_65				
Comment Code					
PR : Prunings					
Inspector Comment					
Remove the pruning from the landside toe.

View of the prunes along the landside toe.

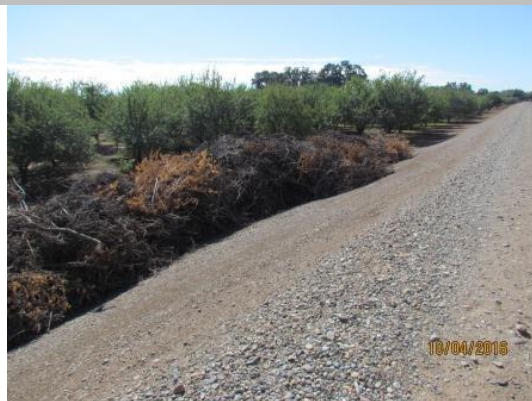
Photo 1 of 1 : FA\_2018\_MA0005\_196\_37\_20180905\_00015.jpg

LM Start	3.06	Rating **	M	Issue No.	37
LM End	3.06	Issue Type +	En	Location *	LS
Category	Earthen Levee			GPS Latitude/Longitude	
				Start	End
Item	Encroachments			39.656911 °	39.656911 °
				-121.787097 °	-121.787097 °
DWR ID	DWR_MA0005_01_f_2015_37				
Comment Code					
PR : Prunings					
Inspector Comment					
Remove the prunings from the landside toe.

View of the prunings along the landside toe.

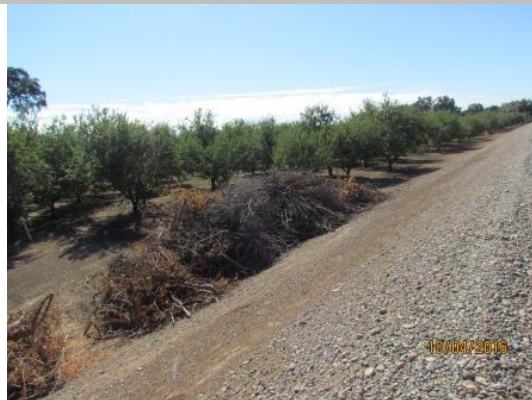
Photo 1 of 1 : FA\_2018\_MA0005\_196\_38\_20180905\_00016.jpg

LM Start	3.21	Rating **	M	Issue No.	38
LM End	3.21	Issue Type +	En	Location *	LS
Category	Earthen Levee			GPS Latitude/Longitude	
				Start	End
Item	Encroachments			39.654938 °	39.654938 °
				-121.787892 °	-121.787892 °
DWR ID	DWR_MA0005_01_f_2015_38				
Comment Code					
PR : Prunings					
Inspector Comment					
Remove the prunings from the landside toe.

View of the prunings along the landside toe.

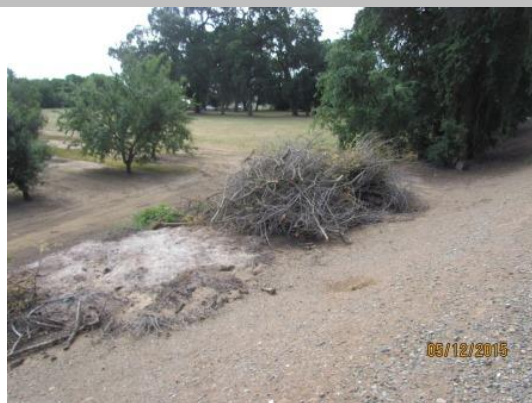
Photo 1 of 1 : FA\_2018\_MA0005\_196\_31\_20180905\_00011.jpg

LM Start	3.42	Rating **	M	Issue No.	31
LM End	3.42	Issue Type +	En	Location *	LS
Category	Earthen Levee			GPS Latitude/Longitude	
				Start	End
Item	Encroachments			39.652028 °	39.652028 °
				-121.789090 °	-121.789090 °
DWR ID	DWR_MA0005_01_s_2015_31				
Comment Code					
PR : Prunings					
Inspector Comment					
Remove the prunings from the landside toe.

View of the prunings along the landside toe.

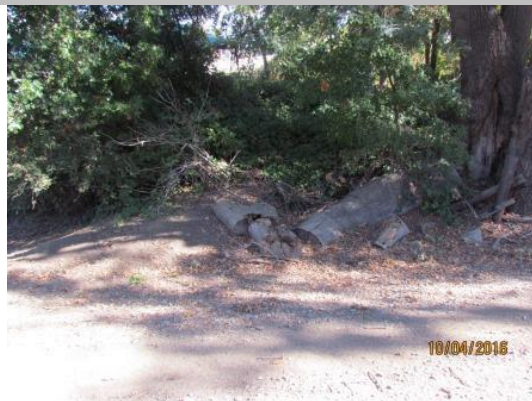
Photo 1 of 1 : FA\_2018\_MA0005\_196\_39\_20180905\_00017.jpg

LM Start	3.60	Rating **	M	Issue No.	39
LM End	3.60	Issue Type +	En	Location *	LS
Category	Earthen Levee			GPS Latitude/Longitude	
				Start	End
Item	Encroachments			39.649641 °	39.649641 °
				-121.788048 °	-121.788048 °
DWR ID	DWR_MA0005_01_f_2016_39				
Comment Code					
DE : Debris					
Inspector Comment					
Remove pile of soil and wood logs from the landside toe.

View of the wood logs and soil along the landside toe.

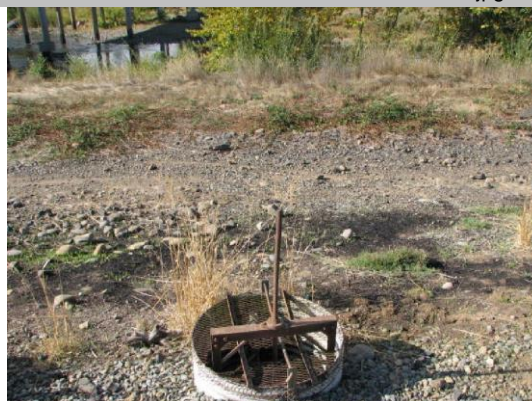
Photo 1 of 3 : UCIP\_FA\_2018\_51949\_67931.jpg

CMP riser and slide gate on WS shoulder.

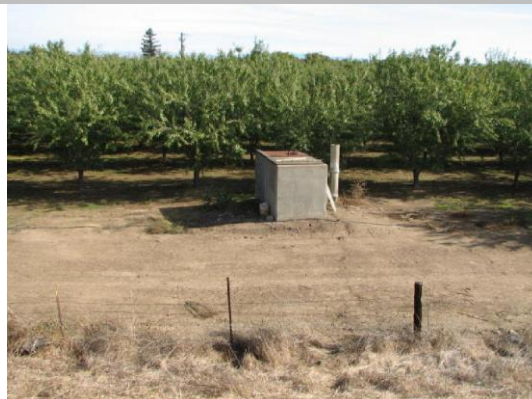
Photo 2 of 3 : UCIP\_FA\_2018\_51949\_67930.jpg

Unable to locate inlet on LS.

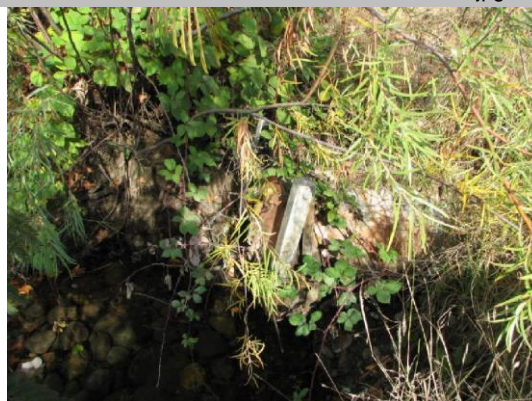
Photo 3 of 3 : UCIP\_FA\_2018\_51949\_67929.jpg

Flap gate in channel at WS toe.

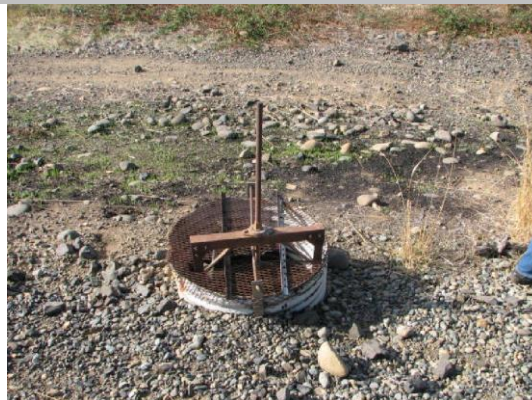
Photo 1 of 3 : UCIP\_FA\_2018\_51950\_67934.jpg

CMP riser and slide gate on WS shoulder.

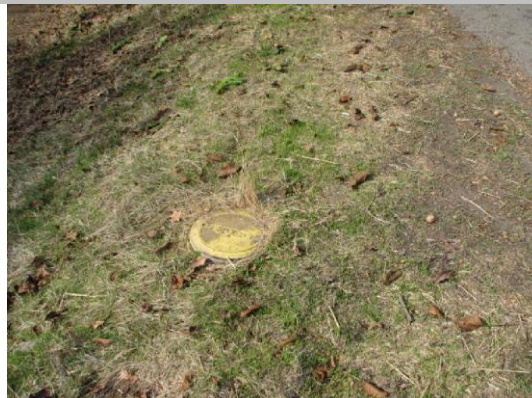
Photo 1 of 2 : UCIP\_FA\_2018\_51952\_67936.jpg

PG&E access lid on south edge of roadway.

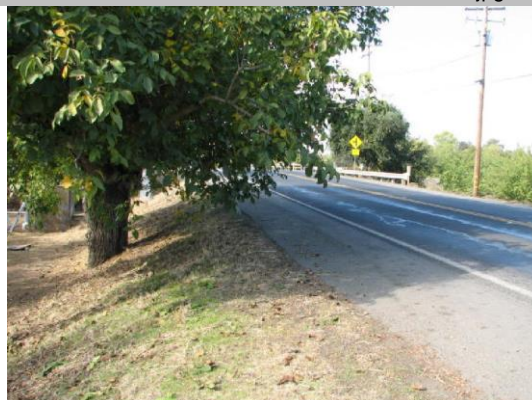
Photo 2 of 2 : UCIP\_FA\_2018\_51952\_67935.jpg

Location of PG&E access lid 250-feet east of levee crown on south side of roadway.

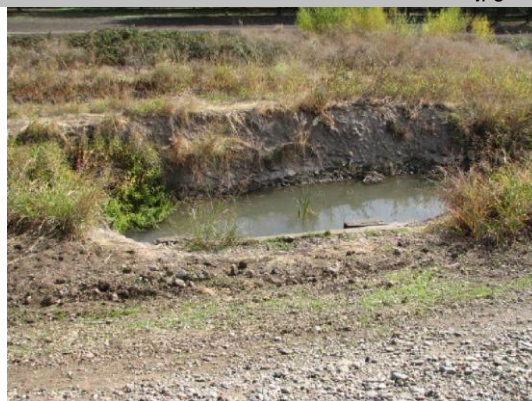
Photo 1 of 3 : UCIP\_FA\_2018\_51954\_67939.jpg

Headwall at LS toe.

Comment Code						
Inspector Comment						
FS_ID:51954 DS_ID:1768 EP_NO: N/A Repair Type: Non-Urgent Crossing Status: Found UCIP Comments: 5/15/2017 Abandoned and needs to be done properly. A sink hole formed in the WS toe road and revealed the location of the WS pipe end. Sink hole will ned to be repaired before the next high water season but the pipe has been selected to be internally cleaned and camera inspected as part of the DMP project so it will have needed to be excavated along the WS end anyways. (DWR Sutter Yard- AFreitag)11/15/2016 Abandoned. Needs standpipe cover. (DWR Sutter Yard- AFreitag)5/9/2016 Abandoned pipe. Needs a cover for standpipe.8/5/2015 Abandoned pipes. Need covers made for tops of standpipes to prevent falls. 12/8/2014 Same as last inspection.6/11/2014 Same as last inspection.11/19/2013 Same as last inspection.5/29/2013 Same as last inspection. Land owner said pipes are abandoned and no longer used. Covers should be made for top of standpipe to prevent falls. Pipes should be properly abandoned.10/30/2012 Pipe 1/2 filled with soil at slide gate on WS. FIELD_STRUCT_DESC: *ABANDONED* 2 of 2: 36-inch corrugated metal drainage pipe through the levee, 11 feet below the crown. Slide gate in a 54-inch corrugated metal riser on the waterside (WS) slope. Concrete "U" shaped headwall on the landside (LS). [Additional Reference(s): DWR Levee Log, 1990. Sacramento O&M Manual 516, April 1960, (Station 470+00)]. FS Date: 5/31/2017 12:52:00 PM

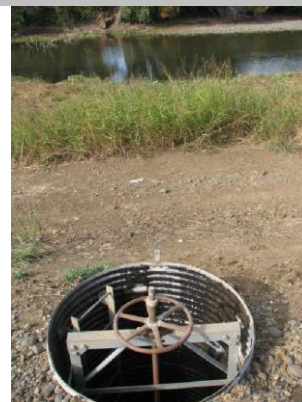
Photo 2 of 2 : UCIP\_FA\_2018\_51955\_67940.jpg

Comment Code					
Inspector Comment					
FS_ID:51955 DS_ID:1620 EP_NO: N/A Repair Type: Non-Urgent Crossing Status: Found UCIP Comments: 5/15/2017 Abandoned and needs to be done properly. A sink hole formed in the WS toe road and revealed the location of the WS pipe end. Sink hole will need to be repaired before the next high water season but the pipe has been selected to be internally cleaned and camera inspected as part of the DMP project so it will have needed to be excavated along the WS end anyways. (DWR Sutter Yard- A Freitag)11/15/2016 Abandoned. Needs cover for the standpipe. (DWR Sutter Yard- A Freitag)5/9/2016 Abandoned pipe. Needs a cover for the standpipe.8/5/2015 Abandoned crossing. Covers need to be made for tops of standpipes to prevent falls.12/8/2014 Same as last inspection.6/11/2014 Same as last inspection.11/19/2013 Same as last inspection.5/29/2013 Same as last inspection. Land owner said pipes are abandoned and no longer used. Covers should be made for top of standpipe to prevent falls. Pipes should be properly abandoned.10/30/2012 Pipe 1/2 filled with soil at slide gate end. FIELD_STRUCT_DESC: *ABANDONED* 1 of 2: 36-inch drainage pipe through the levee, 11 feet below the crown. Slide gate in a 54-inch corrugated metal riser on the waterside (WS) slope. Concrete "U" headwall on the landside (LS). [Additional Reference(s): DWR Levee Log, 1990. Sacramento O&M Manual 516, April 1960 (Station 470+00)]. FS Date: 5/31/2017 1:00:19 PM

54-inch CMP riser and slide gate on WS shoulder.

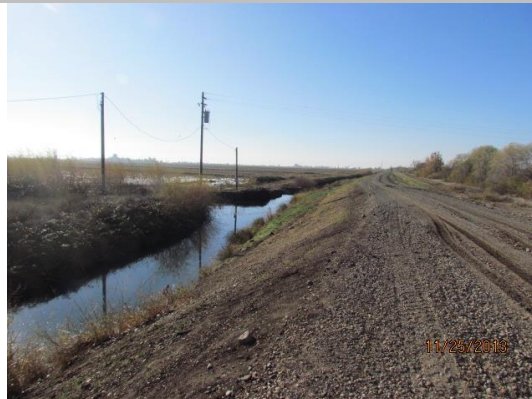
Photo 1 of 1 : FA\_2018\_MA0005\_196\_55\_20180905\_00028.jpg

LM Start	5.69	Rating **	M	Issue No.	55
LM End	6.23	Issue Type +	En	Location *	LS
Category	Earthen Levee			GPS Latitude/Longitude	
				Start	End
Item	Encroachments			39.622766 °	39.615666 °
				-121.773159 °	-121.777353 °
DWR ID	DWR_MA0005_01_s_2015_55				
Comment Code					
DT : Ditch					
Inspector Comment

View of the irrigation ditch along the landside toe.

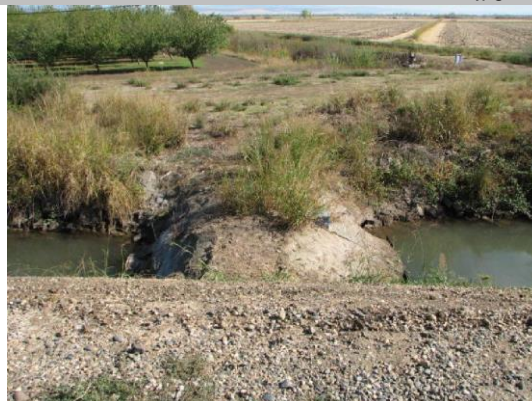
Photo 1 of 1 : UCIP\_FA\_2018\_51958\_11616.jpg

Comment Code						
Inspector Comment						
FS_ID:51958 DS_ID:1622 EP_NO: N/A Repair Type: Non-Urgent Crossing Status: Indicator Found UCIP Comments: 5/15/2017 Unable to locate. (DWR Sutter Yard-AFreitag)11/15/2016 Unable to locate. The concrete fill in the LS toe channel appears to just be erosion protection. (DWR Sutter Yard-AFreitag)8/5/2015 Unable to locate.12/8/2014 Same as last inspection.6/11/2014 Same as last inspection.11/19/2013 Same as last inspection.5/29/2013 Same as last inspection. FIELD_STRUCT_DESC: 18-inch corrugated metal drainage pipe through the levee, 15 feet below the crown, indicator found. Concrete headwall and flap gate on the waterside (WS). Concrete fill in channel on the landside (LS) toe is a good indicator of the pipe location. [Additional Reference(s): DWR Levee Log, 1990. USACE As-Built Drawing No. 50-4-3367, Exhibit B, Sheet 8, April 1957, (Station 480+25)]. FS Date: 5/31/2017 1:06:21 PM

Concrete fill on LS toe a good indicator for location of pipe.

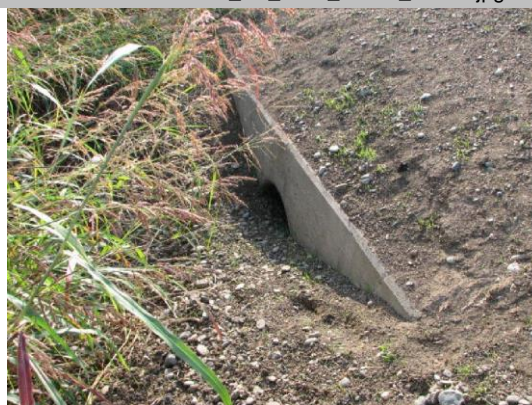
Photo 2 of 2 : UCIP\_FA\_2018\_51970\_67969.jpg

Headwall at LS toe.

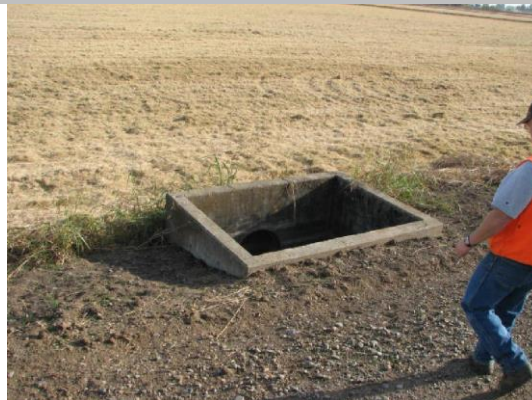
Photo 1 of 3 : UCIP\_FA\_2018\_51975\_67976.jpg

FS\_ID:51975  
DS\_ID:1631  
EP\_NO: N/A  
Repair Type: Non-Urgent  
Crossing Status: Found  
UCIP Comments: 5/16/2017 Abandoned and needs to be done so properly. (DWR Sutter Yard- A Freitag) 11/15/2016 Abandoned. (DWR Sutter Yard- A Freitag) 5/11/2016 Abandoned pipe. 8/4/2015 Abandoned pipe. Casey Wilder has started the steps to have the pipe properly abandoned and removed from the levee. 12/8/2014 Same as last inspection. 6/11/2014 Same as last inspection. 11/19/2013 Same as last inspection. 5/29/2013 Same as last inspection. 10/30/2012 Need to confirm proper abandonment of pipe. Pipe should be plugged on LS.  
FIELD\_STRUCT\_DESC: 16-inch steel irrigation pipe through the levee, 11.5 feet below the crown. Distribution box at the landside (LS) toe.  
[Additional Reference(s): DWR Levee Log, 1990. USACE Sacramento O&M Manual 515, April 1955, (Station 655+68). USACE As-Built Drawing No. 50-4-2637, Exhibit B, Sheet 3, April 1950, (Station 655+68.2)].

Concrete distribution box at LS toe.

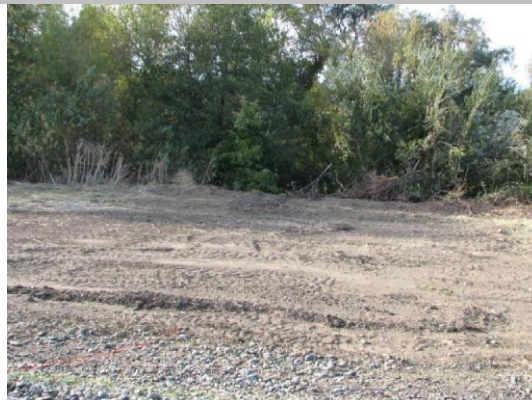
Photo 2 of 3 : UCIP\_FA\_2018\_51975\_67975.jpg

WS shoulder.

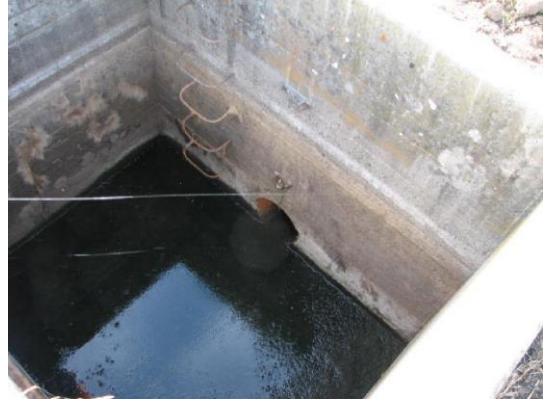
Photo 3 of 3 : UCIP\_FA\_2018\_51975\_67974.jpg

Comment Code						
Inspector Comment						
FS_ID:51975 DS_ID:1631 EP_NO: N/A Repair Type: Non-Urgent Crossing Status: Found UCIP Comments: 5/16/2017 Abandoned and needs to be done so properly. (DWR Sutter Yard- A Freitag)11/15/2016 Abandoned. (DWR Sutter Yard- A Freitag)5/11/2016 Abandoned pipe.8/4/2015 Abandoned pipe. Casey Wilder has started the steps to have the pipe properly abandoned and removed from the levee.12/8/2014 Same as last inspection.6/11/2014 Same as last inspection.11/19/2013 Same as last inspection.5/29/2013 Same as last inspection.10/30/2012 Need to confirm proper abandonment of pipe. Pipe should be plugged on LS. FIELD_STRUCT_DESC: 16-inch steel irrigation pipe through the levee, 11.5 feet below the crown. Distribution box at the landside (LS) toe. [Additional Reference(s): DWR Levee Log, 1990. USACE Sacramento O&M Manual 515, April 1955, (Station 655+68). USACE As-Built Drawing No. 50-4-2637, Exhibit B, Sheet 3, April 1950, (Station 655+68.2)]. FS Date: 5/31/2017 2:09:46 PM

Pipe at bottom of concrete distribution box.

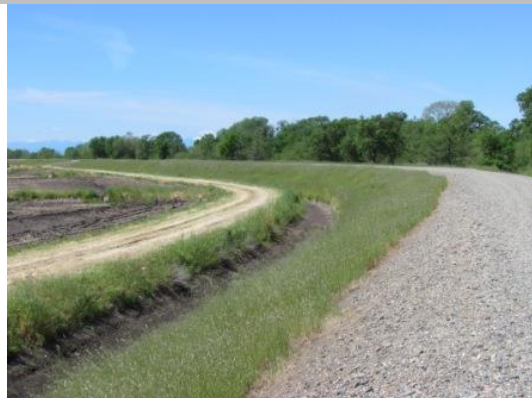
Photo 1 of 1 : FA\_2018\_MA0005\_196\_5\_20180905\_00002.jpg

LM Start	9.54	Rating **	M	Issue No.	5
LM End	10.33	Issue Type +	En	Location *	LS
Category	Earthen Levee			GPS Latitude/Longitude	
				Start	End
Item	Encroachments			39.574837 °	39.567892 °
				-121.807913 °	-121.819283 °
DWR ID	DWR_MA0005_01_s_2012_5				
Comment Code					
DT : Ditch					
Inspector Comment

View of the agricultural ditch along the landside toe.

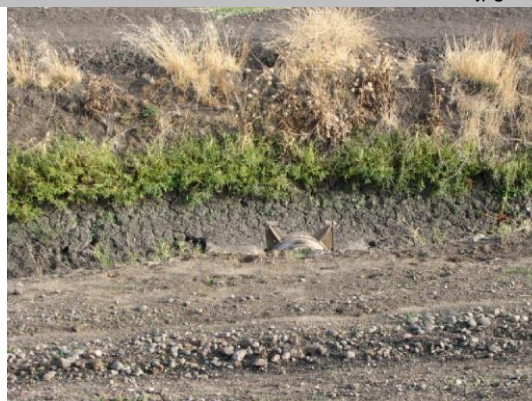
Photo 1 of 1 : UCIP\_FA\_2018\_51980\_67986.jpg

Comment Code					
Inspector Comment					
FS_ID:51980 DS_ID:1633 EP_NO: N/A Repair Type: Non-Urgent Crossing Status: Found UCIP Comments: 5/16/2017 Abandoned crossing and needs to be done so properly. Pipe has been selected to be internally cleaned and inspected as part of the DMP project. (DWR Sutter Yard-AFreitag)11/15/2016 Abandoned. (DWR Sutter Yard-AFreitag)5/11/2016 Abandoned crossing.8/4/2015 Abandoned pipe. Casey Wilder has started the steps to have the pipe properly abandoned and removed from the levee.12/8/2014 Same as last inspection.6/11/2014 Same as last inspection.11/19/2013 Same as last inspection.5/29/2013 Same as last inspection.10/30/2012 Pipe and headwall buried on WS, no access to slide gate. FIELD_STRUCT_DESC: 24-inch corrugated metal irrigation pipe through the levee, 12.5 feet below the crown. Slide gate on the waterside (WS). Flap gate and headwall on the landside (LS). Concrete headwall at the WS toe. [Additional Reference(s): DWR Levee Log, 1990. USACE Sacramento O&M Manual 515, April 1955, (Station 706+00)]. FS Date: 5/31/2017 2:15:33 PM

Flap gate and headwall at LS toe in irrigation or drainage ditch.

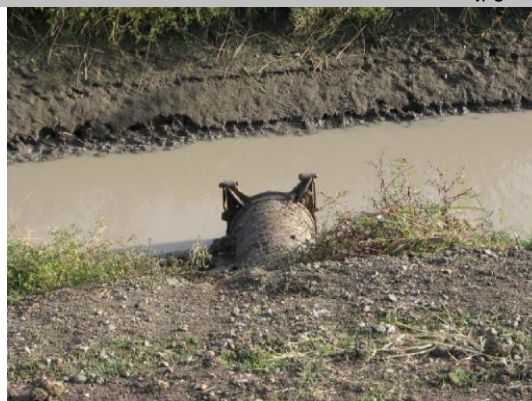
Photo 1 of 3 : UCIP\_FA\_2018\_51981\_67989.jpg

Comment Code						
Inspector Comment						
FS_ID:51981						
DS_ID:1634						
EP_NO: N/A						
Repair Type: Non-Urgent						
Crossing Status: Found						
UCIP Comments: 5/16/2017 Abandoned- needs to be done so properly. Pipe has been selected to be internally cleaned and inspected as part of the DMP project. (DWR Sutter Yard- A Freitag)11/15/2016 Abandoned. (DWR Sutter Yard- A Freitag)5/11/2016 Abandoned crossing.8/4/2015 Abandoned pipe. Casey Wilder has started the steps to have the pipe properly abandoned and removed from the levee.12/8/2014 Same as last inspection.6/11/2014 Same as last inspection.11/19/2013 Same as last inspection.5/29/2013 Same as last inspection.						
FIELD_STRUCT_DESC: 24-inch corrugated metal irrigation pipe through the levee, 14.5 feet below the crown. Slide gate on the waterside (WS) on concrete headwall. Flap gate on the landside (LS). [Additional Reference(s): DWR Levee Log, 1990. USACE Sacramento O&M Manual 515, April 1955, (Station 717+50)].

Pipe and flap gate on LS toe.

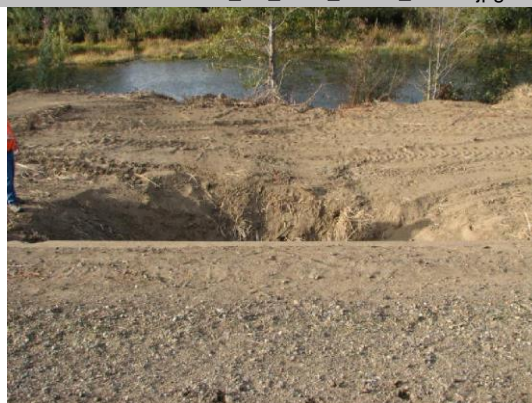
Photo 2 of 3 : UCIP\_FA\_2018\_51981\_67988.jpg

headwall at WS toe.

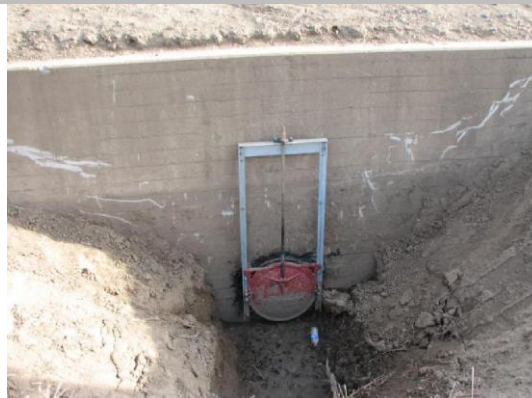
Photo 3 of 3 : UCIP\_FA\_2018\_51981\_67987.jpg

Item	DWR UCIP Field Study			39.568523 °	39.568523 °	
				-121.818232 °	-121.818232 °	
DWR ID	1634					
Comment Code						
Inspector Comment						
FS_ID:51981 DS_ID:1634 EP_NO: N/A Repair Type: Non-Urgent Crossing Status: Found UCIP Comments: 5/16/2017 Abandoned- needs to be done so properly. Pipe has been selected to be internally cleaned and inspected as part of the DMP project. (DWR Sutter Yard- A Freitag)11/15/2016 Abandoned. (DWR Sutter Yard- A Freitag)5/11/2016 Abandoned crossing.8/4/2015 Abandoned pipe. Casey Wilder has started the steps to have the pipe properly abandoned and removed from the levee.12/8/2014 Same as last inspection.6/11/2014 Same as last inspection.11/19/2013 Same as last inspection.5/29/2013 Same as last inspection. FIELD_STRUCT_DESC: 24-inch corrugated metal irrigation pipe through the levee, 14.5 feet below the crown. Slide gate on the waterside (WS) on concrete headwall. Flap gate on the landside (LS). [Additional Reference(s): DWR Levee Log, 1990. USACE Sacramento O&M Manual 515, April 1955, (Station 717+50)]. FS Date: 5/31/2017 2:16:48 PM

Headwall and slide gate on WS toe.

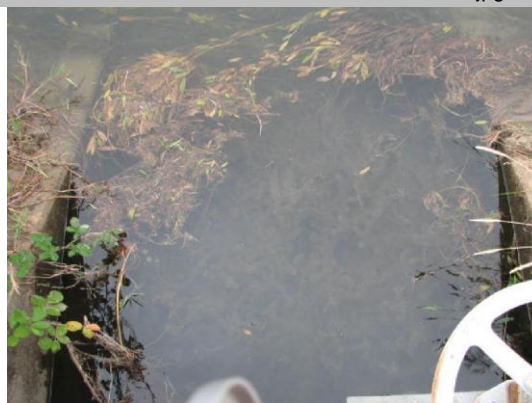
Photo 1 of 3 : UCIP\_FA\_2018\_51988\_68002.jpg

Comment Code						
Inspector Comment						
FS_ID:51988 DS_ID:1781 EP_NO: 16667 Repair Type: Non-Urgent Crossing Status: Found UCIP Comments: 5/16/2017 LS appears to be in good condition. WS outlet is too heavily vegetated to be inspected. Vegetation needs to be cleared back. Pipe has been selected to be internally cleaned and inspected as part of the DMP project. (DWR Sutter Yard- A Freitag)11/15/2016 Crossing appears to be in good condition. (DWR Sutter Yard- A Freitag)5/11/2016 Crossing appears to be in good condition.8/4/2015 Crossing appears in good condition. No noticeable issues to report.6/11/2014 Same as last inspection.11/19/2013 Same as last inspection.5/29/2013 Same as last inspection. FIELD_STRUCT_DESC: [Western Canal Siphon] 5 of 5: 18-inch reinforced concrete irrigation pipe through the levee, at an unknown depth. Pipe terminates at a concrete outlet on the waterside (WS) slope. Concrete headwalls on both the landside (LS) and the WS. Slide gate and air vent on the LS. This is a turnout that was installed for the use of the property owner. (Permit No. 16667, 1997 - Western Canal Water District). FS Date: 5/31/2017 2:23:27 PM

Concrete U shaped headwall at inlet in canal on LS.

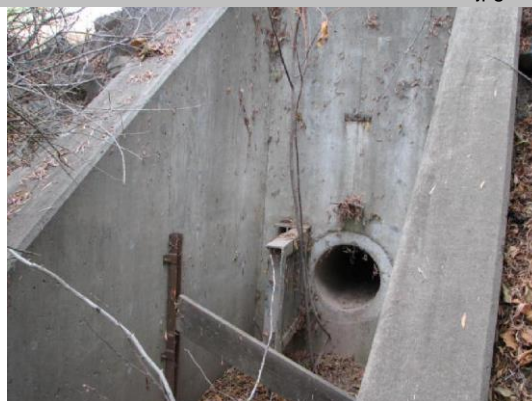
Photo 2 of 3 : UCIP\_FA\_2018\_51988\_68001.jpg

Item	DWR UCIP Field Study			39.561483 °	39.561483 °	
				-121.826939 °	-121.826939 °	
DWR ID	1781					
Comment Code						
Inspector Comment						
FS_ID:51988 DS_ID:1781 EP_NO: 16667 Repair Type: Non-Urgent Crossing Status: Found UCIP Comments: 5/16/2017 LS appears to be in good condition. WS outlet is too heavily vegetated to be inspected. Vegetation needs to be cleared back. Pipe has been selected to be internally cleaned and inspected as part of the DMP project. (DWR Sutter Yard-AFreitag)11/15/2016 Crossing appears to be in good condition. (DWR Sutter Yard- AFreitag)5/11/2016 Crossing appears to be in good condition.8/4/2015 Crossing appears in good condition. No noticeable issues to report.6/11/2014 Same as last inspection.11/19/2013 Same as last inspection.5/29/2013 Same as last inspection. FIELD_STRUCT_DESC: [Western Canal Siphon] 5 of 5: 18-inch reinforced concrete irrigation pipe through the levee, at an unknown depth. Pipe terminates at a concrete outlet on the waterside (WS) slope. Concrete headwalls on both the landside (LS) and the WS. Slide gate and air vent on the LS. This is a turnout that was installed for the use of the property owner. (Permit No. 16667, 1997 - Western Canal Water District). FS Date: 5/31/2017 2:23:27 PM

Concrete U shaped outlet on WS slope.

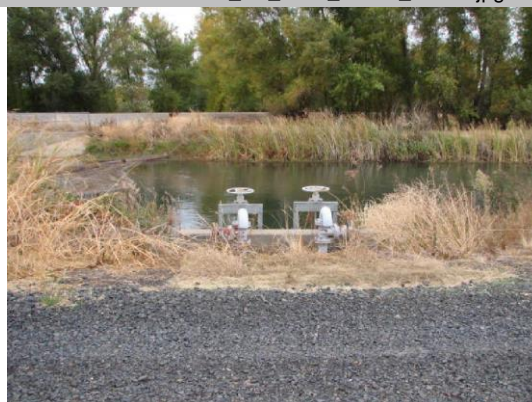
Photo 3 of 3 : UCIP\_FA\_2018\_51988\_68000.jpg

Air vents, slide gates, and concrete headwall at south side of canal on LS.

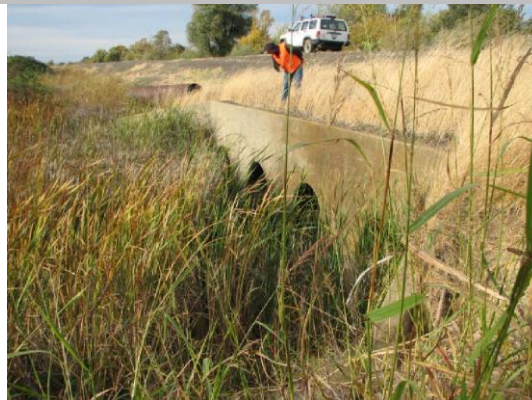
Photo 2 of 2 : UCIP\_FA\_2018\_51990\_68006.jpg

LS intake headwall.

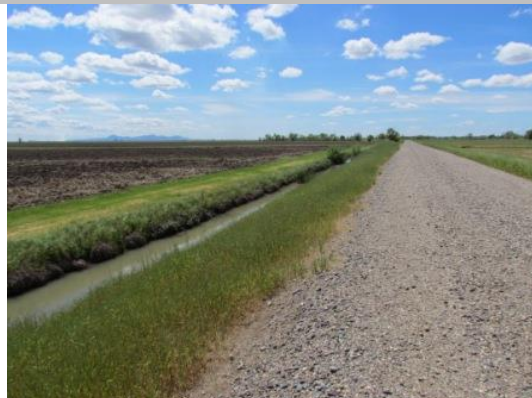
Photo 1 of 1 : FA\_2018\_MA0005\_196\_6\_20180905\_00003.jpg

LM Start	11.85	Rating **	M	Issue No.	6
LM End	13.64	Issue Type +	En	Location *	LS
Category	Earthen Levee			GPS Latitude/Longitude	
				Start	End
Item	Encroachments			39.551235 °	39.531462 °
				-121.837697 °	-121.856165 °
DWR ID	DWR_MA0005_01_s_2012_6				
Comment Code					
DT : Ditch					
Inspector Comment

View of the agricultural ditch along the landside toe.

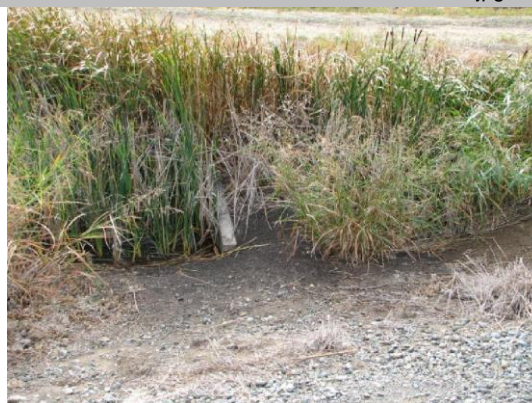
Photo 1 of 1 : UCIP\_FA\_2018\_51996\_68025.jpg

Comment Code						
Inspector Comment						
FS_ID:51996 DS_ID:1747 EP_NO: N/A Repair Type: Non-Urgent Crossing Status: Indicator Found UCIP Comments: 5/16/2017 Pipe is buried on both sides of the levee. Unable to locate. (DWR Sutter Yard- AFreitag)11/15/2016 Buried on both sides of Levee. (DWR Sutter Yard - AFreitag)5/11/2016 Buried pipe.8/4/2015 Pipe is buried on both ends.6/11/2014 Same as last inspection.11/19/2013 Same as last inspection.5/29/2013 Same as last inspection.10/31/2012 Pipe buried on both LS and WS. FIELD_STRUCT_DESC: 48-inch corrugated metal irrigation pipe through the levee, at an unknown depth, indicator found. 48-inch corrugated metal riser and a sparling water meter/irrigation structure on the landside (LS). 4-foot by 6-foot concrete distribution box at the LS toe. [Additional Reference(s): USACE Sacramento O&M Manual 515, April 1955, (Station 836+86). USACE As-Built Drawing No. 50-4-2637, Exhibit B, Sheet 4, April 1950, (Station 836+86)]. FS Date: 5/31/2017 2:34:41 PM

Buried pipe at concrete box, LS toe.

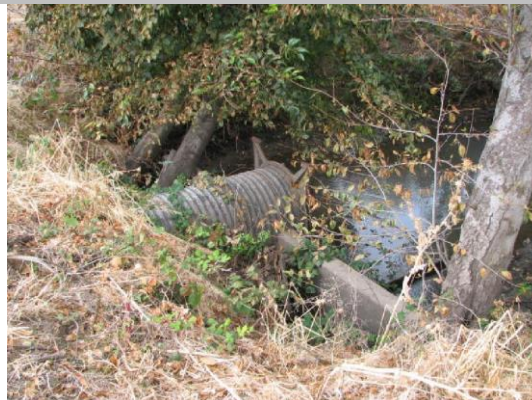
Photo 2 of 3 : UCIP\_FA\_2018\_51999\_68032.jpg

Item	DWR UCIP LMA Responsibility			39.522200 °	39.522200 °	
				-121.865592 °	-121.865592 °	
DWR ID	1639					
Comment Code						
Inspector Comment						
FS_ID:51999 DS_ID:1639 EP_NO: N/A Repair Type: Non-Urgent Crossing Status: Found UCIP Comments: 5/16/2017 Soil still eroded away from the WS wing walls. Pipe has been selected to be internally cleaned and inspected as part of the DMP project. (DWR Sutter Yard- AFreitag)11/15/2016 No soil supporting the WS wing walls. (DWR Sutter Yard- AFreitag)5/11/2016 Still no soil supporting the WS wing walls and apron. WS vegetation was thinner and not a problem this time.8/4/2015 No soil supporting the WS wing walls at the WS pipe end. WS pipe end is also being overgrown with vegetation and should be cleared back.6/11/2014 Same as last inspection.11/19/2013 Same as last inspection.5/29/2013 Same as last inspection.10/31/2012 Soil under Concrete wing walls on WS toe has been eroded. No soil supporting wing walls. FIELD_STRUCT_DESC: 36-inch corrugated metal drainage pipe through the levee, 13 feet below the crown. Flap gate on the waterside (WS). Concrete headwalls on the landside (LS) and the WS ends. [Additional Reference(s): DWR Levee Log, 1990. USACE Sacramento O&M Manual 515, April 1955, (Station 978+25). USACE As-Built Drawing No. 50-4-2637, Exhibit B, Sheet 5, April 1950, (Station 978+24.95)]. FS Date: 5/31/2017 2:39:05 PM

CMP pipe, flap gate, and headwall on WS toe.

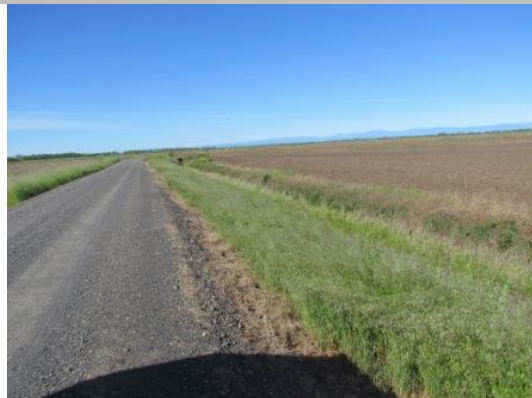
Photo 1 of 1 : FA\_2018\_MA0005\_197\_1\_20180905\_00001.jpg

LM Start	1.21	Rating **	M	Issue No.	1
LM End	1.59	Issue Type +	En	Location *	LS
Category	Earthen Levee			GPS Latitude/Longitude	
				Start	End
Item	Encroachments			39.529933 °	39.534102 °
				-121.861563 °	-121.856947 °
DWR ID	DWR_MA0005_02_s_2012_1				
Comment Code					
DT : Ditch					
Inspector Comment

View of the agricultural ditch along the landside toe.

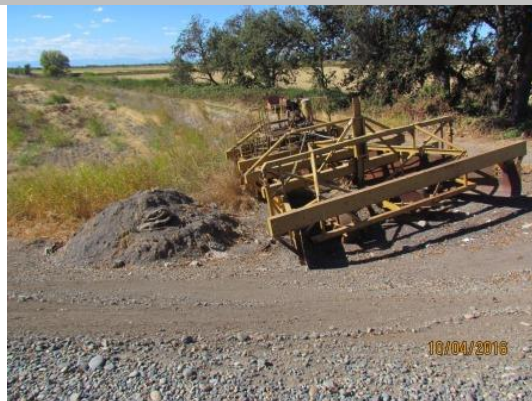
Photo 1 of 1 : FA\_2018\_MA0005\_197\_48\_20180905\_00023.jpg

View of soil pile, rocks, and ag equipment.

LM Start	1.86	Rating **	M	Issue No.	48
LM End	1.86	Issue Type +	En	Location *	LS
Category	Earthen Levee			GPS Latitude/Longitude	
				Start	End
Item	Encroachments			39.536915 °	39.536915 °
				-121.853669 °	-121.853669 °
DWR ID	DWR_MA0005_02_f_2016_48				
Comment Code					
EQ : Equipment					
Inspector Comment					
Remove pile of soil and rocks and ag equipment from the toe of the levee.

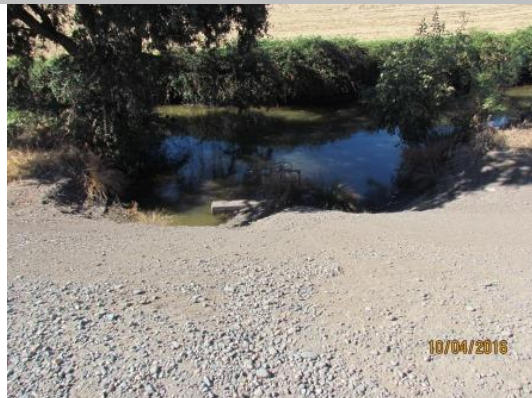
Photo 1 of 1 : FA\_2018\_MA0005\_197\_49\_20180905\_00024.jpg

View of the landside toe erosion.

LM Start	1.90	Rating **	M	Issue No.	49
LM End	1.90	Issue Type +	Ma	Location *	LS
Category	Earthen Levee			GPS Latitude/Longitude	
				Start	End
Item	Erosion / Bank Caving			39.537445°	39.537445°
				-121.853112°	-121.853112°
DWR ID	DWR_MA0005_02_f_2016_49				
Comment Code					
E2 : Schedule repair of erosion site prior to the next inspection.					
Inspector Comment					
Repair the erosion on the landside toe of the levee.

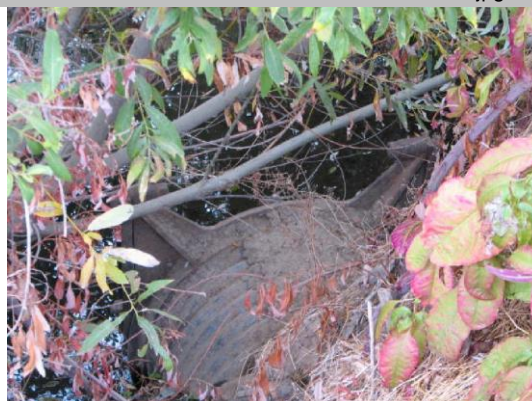
Photo 2 of 3 : UCIP\_FA\_2018\_53009\_68496.jpg

FS\_ID:53009  
DS\_ID:1645  
EP\_NO: N/A  
Repair Type: Urgent  
Crossing Status: Found  
UCIP Comments: 10/5/2018 Unable to see pipe on waterside due to high water level in the creek. Erosion is present around headwall on LS. Screw gate on LS blocked with silt approximately halfway in height. (O.Yakimov - DWR) 5/18/2017 LS erosion still present. Ws flap gate has been completely buried by sediment after the high water flows through the area. Pipe has been selected to be internally cleaned and inspected as part of the DMP project. (DWR Sutter Yard- AFreitag)11/14/2016 LS erosion still present and is into the prism of the levee. WS flap gate was still mostly buried and non-operational. (DWR Sutter Yard- AFreitag)5/23/2016 The tree that was overgrowing the WS flapgate has been removed. Flap gate was half buried and unable to open. Erosion on the LS is still present. (DWR Sutter Yard - afreitag)7/28/2015 LS inlet is underwater but there appears to be erosion behind the LS headwall. WS pipe end and flap gate are completely overgrown and inaccessible for inspection. (DWR Sutter Yard - afreitag)11/25/2014 Tree is overgrowing the WS pipe outlet.. Needs to be trimmed back. (DWR Sutter Yard - afreitag)6/4/2014 Same as last inspection. (DWR Sutter Yard - afreitag)11/12/2013 Same as last inspection. (DWR Sutter Yard - afreitag)6/6/2013 Same as last inspection. (DWR Sutter Yard - afreitag)10/31/2012 Vegetation needs to be cleared from outlet. (DWR UCIP - wwylie)

Flap gate on WS slope.

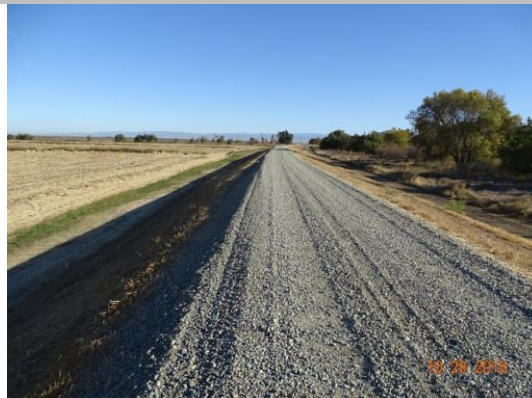
Photo 1 of 1 : FA\_2018\_MA0005\_197\_63\_20181102\_00100.jpg

LM Start	2.80	Rating **	A	Issue No.	63
LM End	2.80	Issue Type +	Ma	Location *	LS
Category	Earthen Levee			GPS Latitude/Longitude	
				Start	End
Item	Vegetation			39.548043 °	39.548043 °
				-121.843612 °	-121.843612 °
DWR ID	DWR_MA0005_02_f_2018_63				
Comment Code					
V1 : Control annual grass and weeds on the levee slopes and easements.					
Inspector Comment					
The vegetation was mowed on both slope.

View of the mowed vegetation on both slopes.

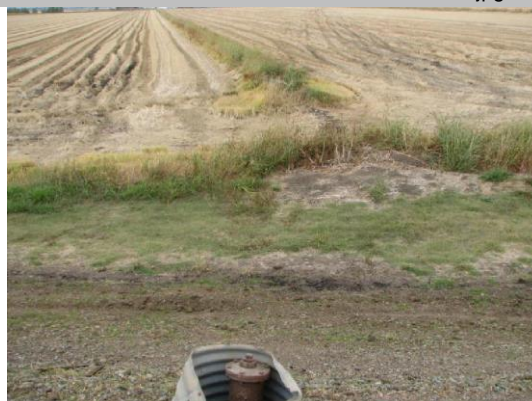
Photo 1 of 3 : UCIP\_FA\_2018\_52013\_68057.jpg

Comment Code						
Inspector Comment						
FS_ID:52013 DS_ID:1646 EP_NO: 3927 Repair Type: Non-Urgent Crossing Status: Found UCIP Comments: 5/18/2017 Appears to have been abandoned. Pump is missing from the pier and there is no sign of the riser and siphon breaker on the LS shoulder. (DWR Sutter Yard- A/Freitag)11/14/2016 Appears abandoned- pump removed from pier in Butte Creek also riser and siphon breaker are no longer seen on LS shoulder. (DWR Sutter Yard- A/Freitag)5/23/2016 Crossing appears to have been abandoned and removed. Could not locate the LS riser and siphon breaker.7/28/2015 No pump present during any of my inspections. Crossing appears abandoned. CMP riser has been knocked out of levee. 11/25/2014 Same as last inspection.6/04/2014 Same as last inspection.11/12/2013 Same as last inspection.6/6/2013 Same as last inspection.10/31/2012 Pump does not appear to be in use or is abandoned. FIELD_STRUCT_DESC: 20-inch (not 18-inch as referenced in the levee log) exterior coated steel irrigation pipe through the levee, 2.4 feet below the crown. Siphon breaker in a 24-inch corrugated metal riser on the landside (LS) shoulder. Portable pump on the waterside (WS). (Permit No. 3927, 1962 - Arrowhead Ranch). [Additional Reference(s): DWR Levee Log, 1990]. FS Date: 6/1/2017 9:46:03 AM

Air vent in 24-inch CMP riser on LS shoulder.

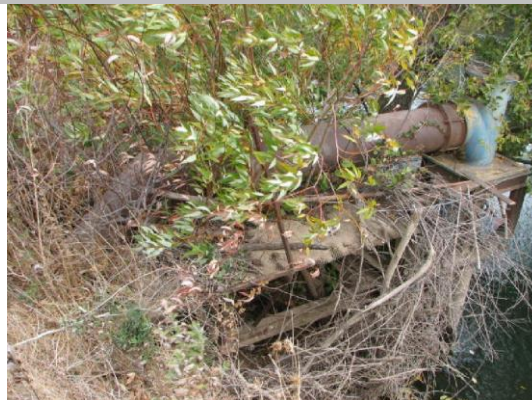
Photo 2 of 3 : UCIP\_FA\_2018\_52013\_68056.jpg

FS\_ID:52013  
DS\_ID:1646  
EP\_NO: 3927  
Repair Type: Non-Urgent  
Crossing Status: Found  
UCIP Comments: 5/18/2017 Appears to have been abandoned. Pump is missing from the pier and there is no sign of the riser and siphon breaker on the LS shoulder. (DWR Sutter Yard- AFreitag)11/14/2016 Appears abandoned- pump removed from pier in Butte Creek also riser and siphon breaker are no longer seen on LS shoulder. (DWR Sutter Yard- AFreitag)5/23/2016 Crossing appears to have been abandoned and removed. Could not locate the LS riser and siphon breaker.7/28/2015 No pump present during any of my inspections. Crossing appears abandoned. CMP riser has been knocked out of levee. 11/25/2014 Same as last inspection.6/04/2014 Same as last inspection.11/12/2013 Same as last inspection.6/6/2013 Same as last inspection.10/31/2012 Pump does not appear to be in use or is abandoned.  
FIELD\_STRUCT\_DESC: 20-inch (not 18-inch as referenced in the levee log) exterior coated steel irrigation pipe through the levee, 2.4 feet below the crown. Siphon breaker in a 24-inch corrugated metal riser on the landside (LS) shoulder. Portable pump on the waterside (WS). (Permit No. 3927, 1962 - Arrowhead Ranch). [Additional Reference(s): DWR Levee Log, 1990].

Pump on metal pier at WS toe.

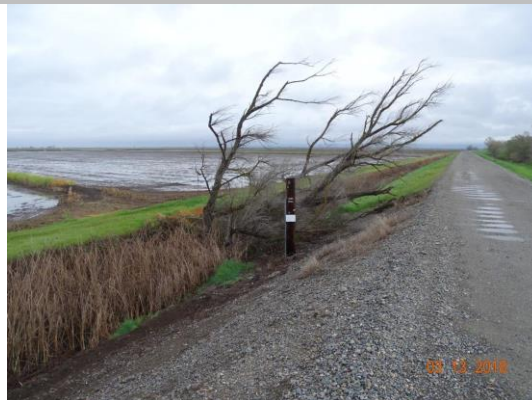
Photo 1 of 1 : FA\_2018\_MA0005\_197\_64\_20180905\_00033.jpg

View of the tree on the landside slope and toe.

LM Start	3.10	Rating **	M	Issue No.	64
LM End	3.10	Issue Type +	Ma	Location *	LS
Category	Earthen Levee			GPS Latitude/Longitude	
				Start	End
Item	Encroachments			39.551747 °	39.551747 °
				-121.840568 °	-121.840568 °
DWR ID	DWR_MA0005_02_s_2018_64				
Comment Code					
TR : Tree or limb					
Inspector Comment					
Remove the tree from the landside slope and toe.

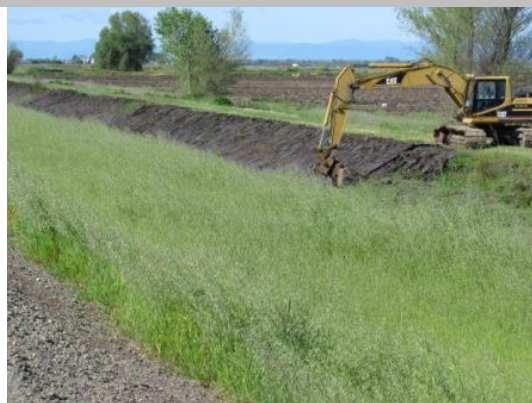
Photo 1 of 1 : FA\_2018\_MA0005\_197\_7\_20180905\_00004.jpg

LM Start	3.10	Rating **	M	Issue No.	7
LM End	4.04	Issue Type +	En	Location *	LS
Category	Earthen Levee			GPS Latitude/Longitude	
				Start	End
Item	Encroachments			39.551780 °	39.562341 °
				-121.840507 °	-121.829507 °
DWR ID	DWR_MA0005_02_s_2012_7				
Comment Code					
DT : Ditch					
Inspector Comment

View of the agricultural ditch along the landside toe.

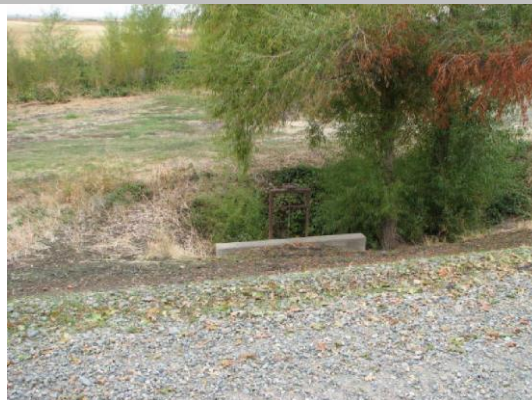
Photo 1 of 3 : UCIP\_FA\_2018\_52014\_68064.jpg

FS\_ID:52014  
DS\_ID:1647  
EP\_NO: N/A  
Repair Type: No Action Needed  
Crossing Status: Found  
UCIP Comments: 5/18/2017 Crossing appears to be in good condition. Tree near the LS screw gate could use some trimming. Pipe has been selected to be internally cleaned and inspected as part of the DMP project. (DWR Sutter Yard- A Freitag) 11/14/2016 Crossing appears to be in good condition. (DWR Sutter Yard- A Freitag) 5/23/2016 Crossing appears to be in good condition. 7/28/2015 Pipe appears in good condition. No noticeable issues to report. 6/6/2013 Same as last inspection. 11/12/2013 Same as last inspection. 6/04/2014 Same as last inspection. 11/25/2014 Same as last inspection.  
FIELD\_STRUCT\_DESC: 30-inch corrugated metal drainage pipe through the levee, 14.3 feet below the crown. Slide gate on the landside (LS). Flap gate on the waterside (WS). Concrete headwall at the LS toe. Concrete splash apron on the WS. [Additional Reference(s): DWR Levee Log, 1990. USACE Sacramento O&M Manual 515, April 1955, (Station 5+20""A""). USACE As-Built Drawing No. 50-4-2637, Exhibit B, Sheet 4, April 1950, (Station 5+20""A"").]

Concrete headwall and slide gate at LS toe.

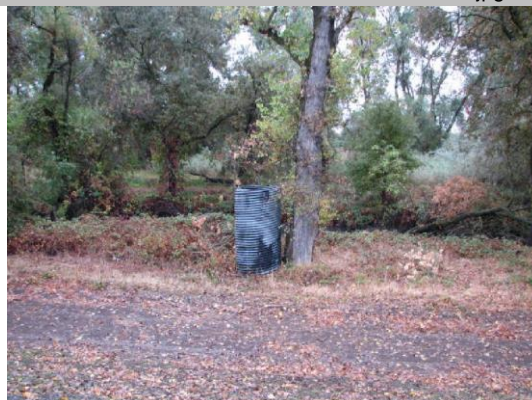
Photo 2 of 2 : UCIP\_FA\_2018\_52042\_68104.jpg

56-inch CMP riser on WS berm.

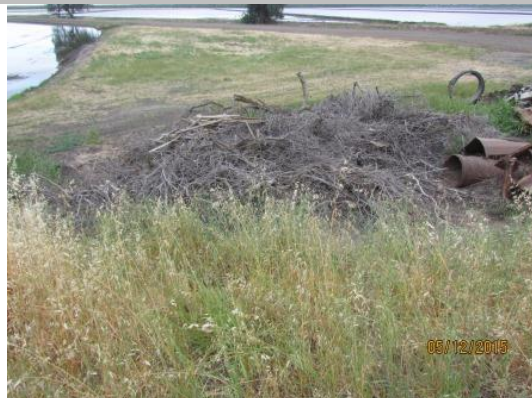
Photo 1 of 1 : FA\_2018\_MA0005\_197\_34\_20180905\_00011.jpg

View of the prunings along the landside toe.

LM Start	5.91	Rating **	M	Issue No.	34
LM End	5.91	Issue Type +	En	Location *	LS
Category	Earthen Levee			GPS Latitude/Longitude	
				Start	End
Item	Encroachments			39.583052 °	39.583052 °
				-121.807423 °	-121.807423 °
DWR ID	DWR_MA0005_02_s_2015_34				
Comment Code					
PR : Prunings					
Inspector Comment					
Remove the prunings and broken metal and concrete pipes from the landside toe.

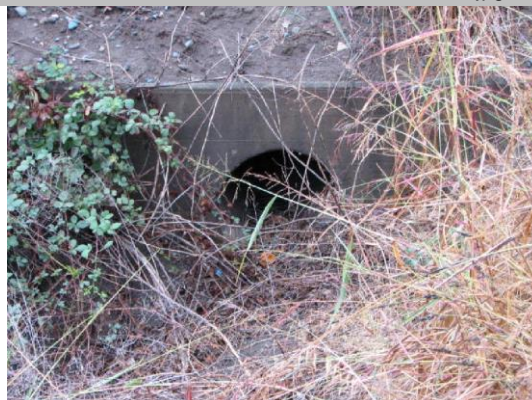
Photo 3 of 3 : UCIP\_FA\_2018\_52049\_68120.jpg

Headwall on LS toe.
